SSC-337

SHIP FRACTURE MECHANISMS INVESTIGATION

SHIP STRUCTURE COMMITTEE

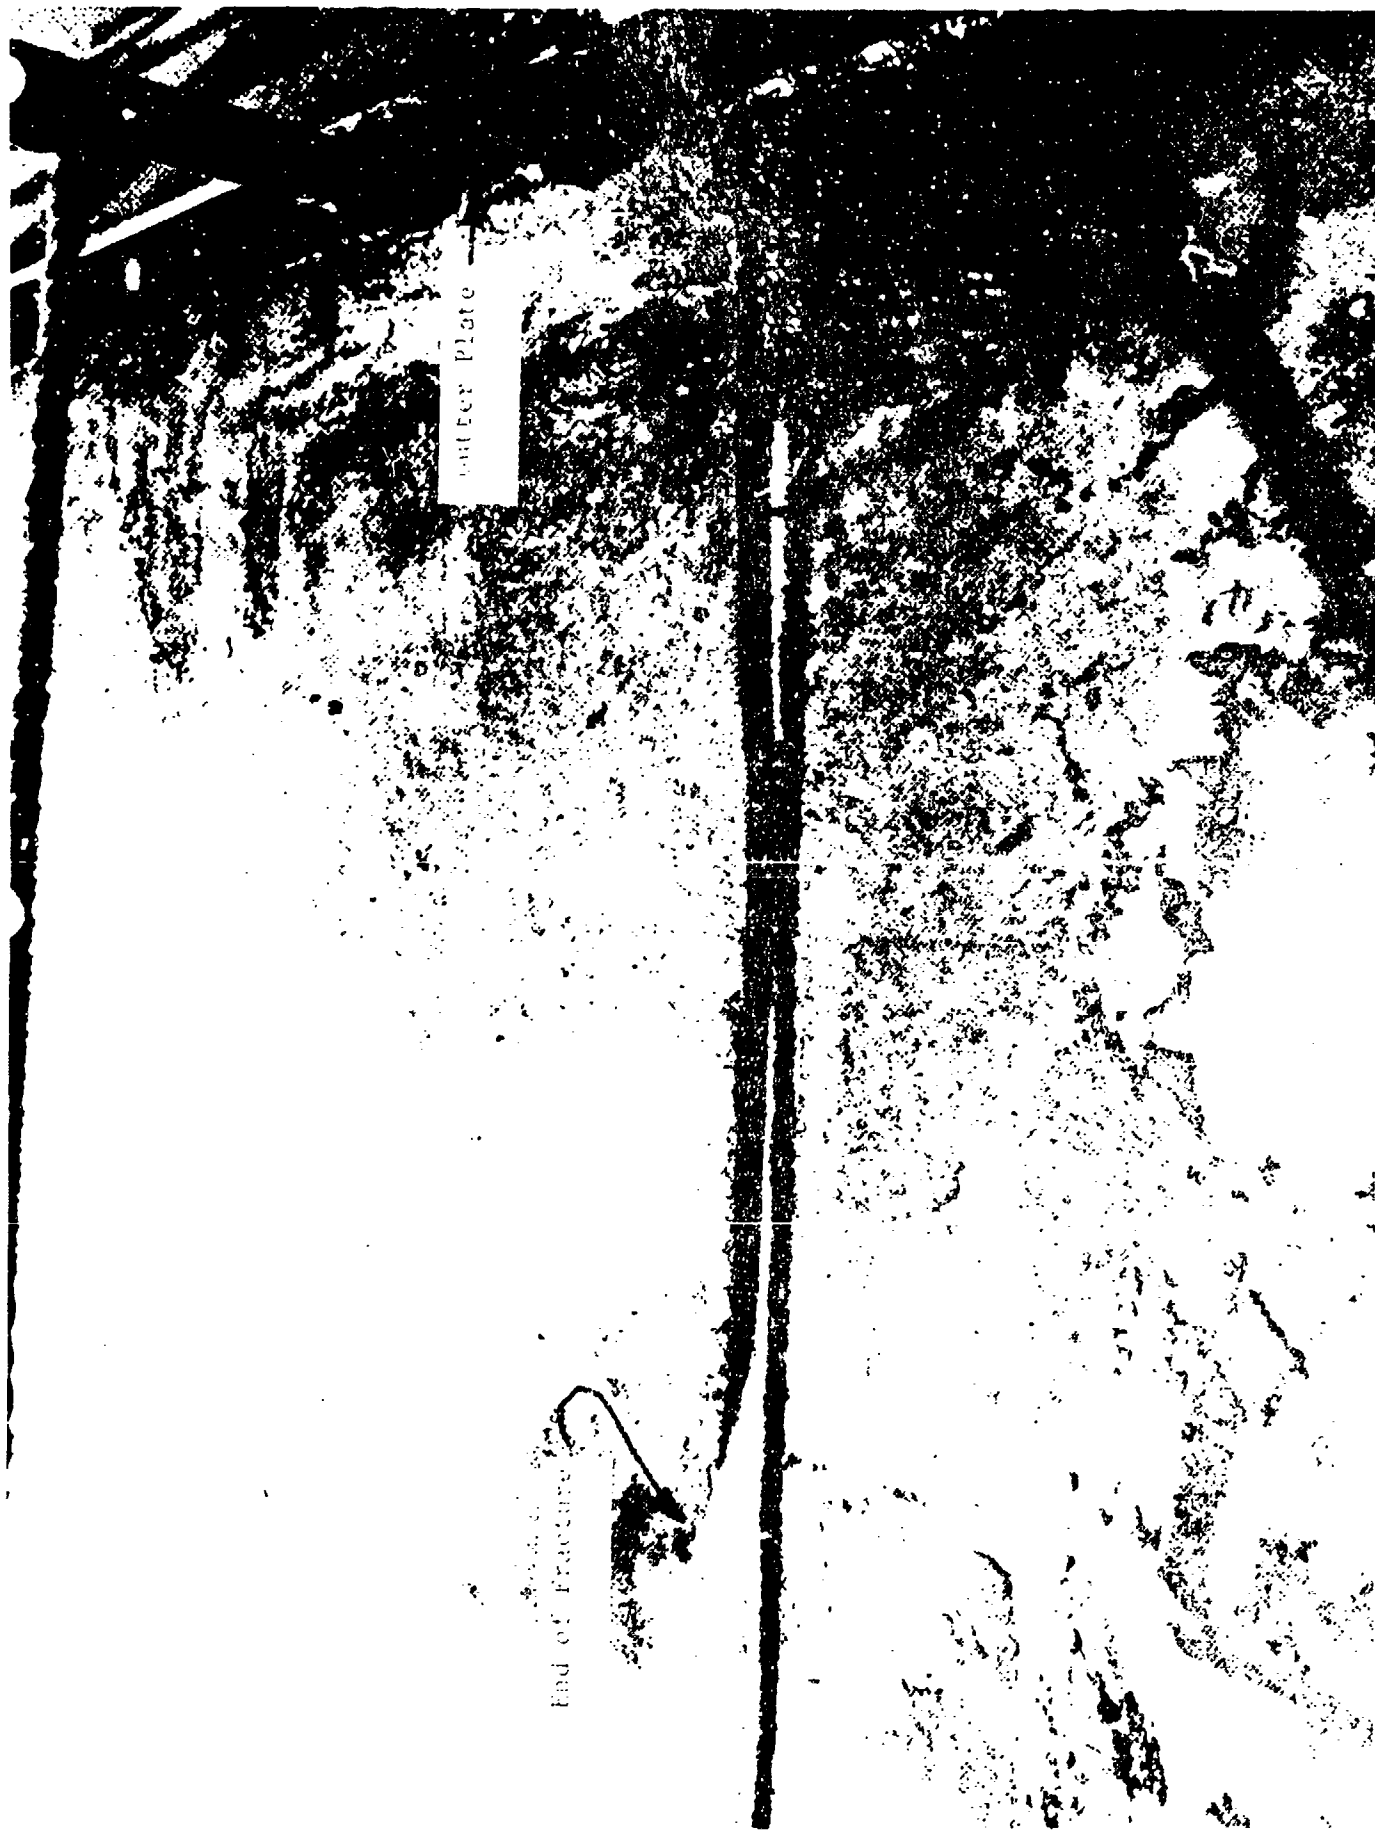
Figure 4-16 Fracture across the deck. Fracture was entirely in the plate with the fracture surface about 45° to the plate surface.

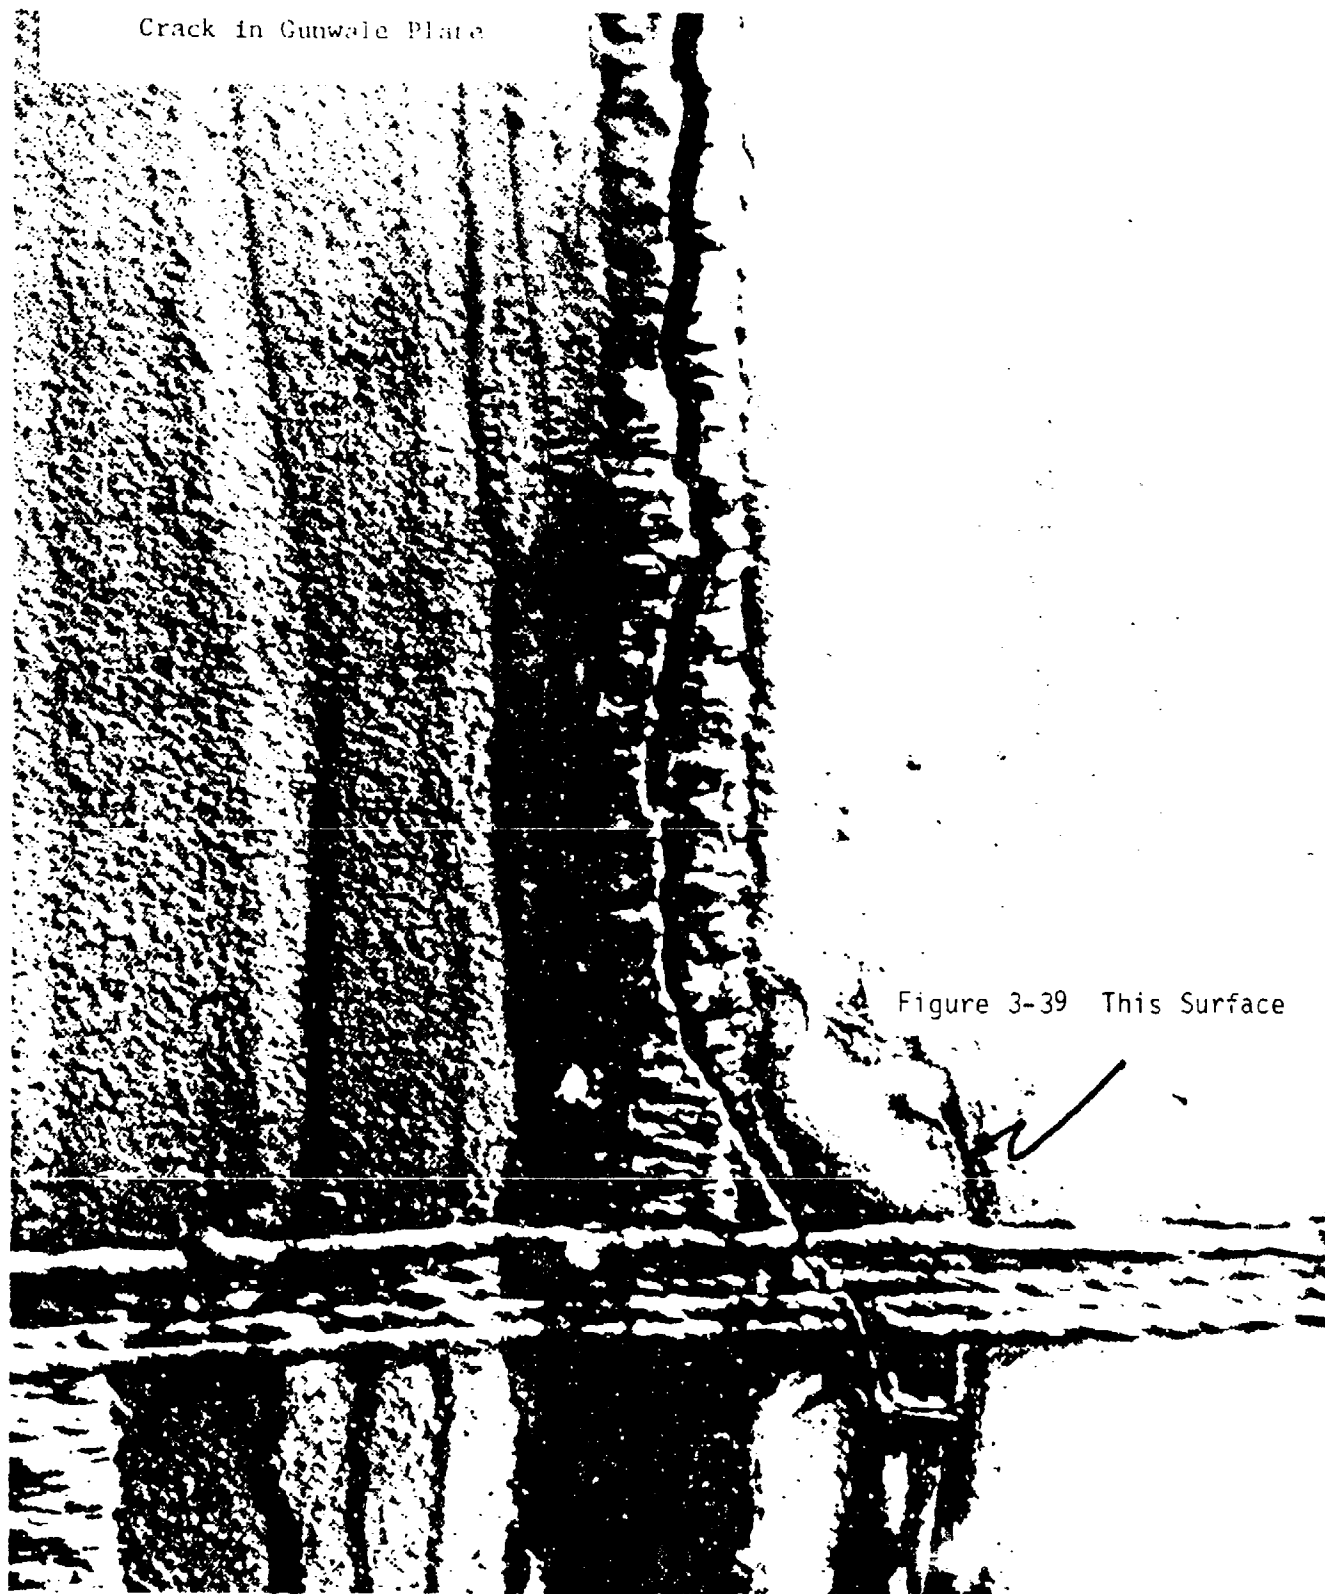
Figure 3-38 - Junction of main side shell fracture with the fracture through the weld of the gunwale plate.

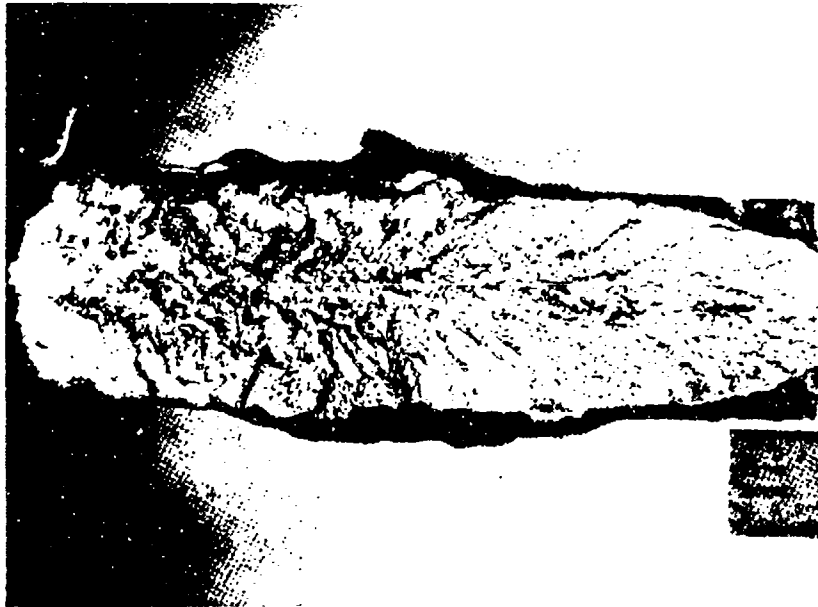
Figure 3-39 Fracture Face at End of Main Shell Fracture, see Figure 3-38. Note Chevron pattern and apparent "necking down" associated with fracture arrest. Specimen 3908, Magn. 1.2X.

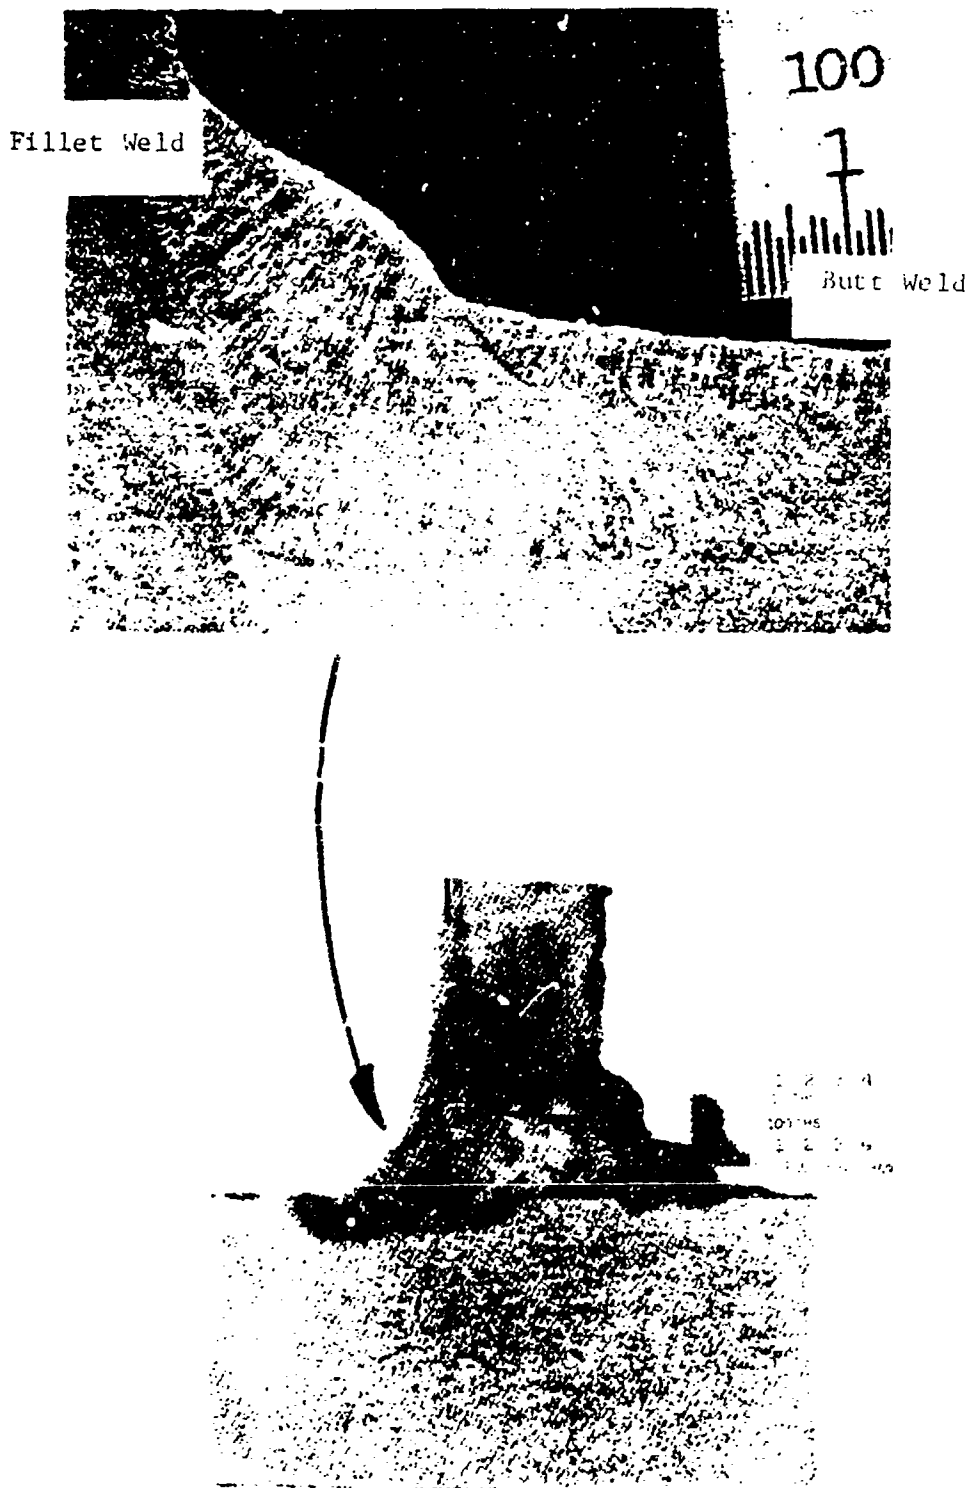
Figure 3-44 Juncture of Fillet and Butt Welds at Line A-B of Figure 3-43. Detail shows that butt weld was made over the fillet weld. Specimen No. 3908. Etch: Ammonium Persulfate; Magn. 1.5x & 5.7x.

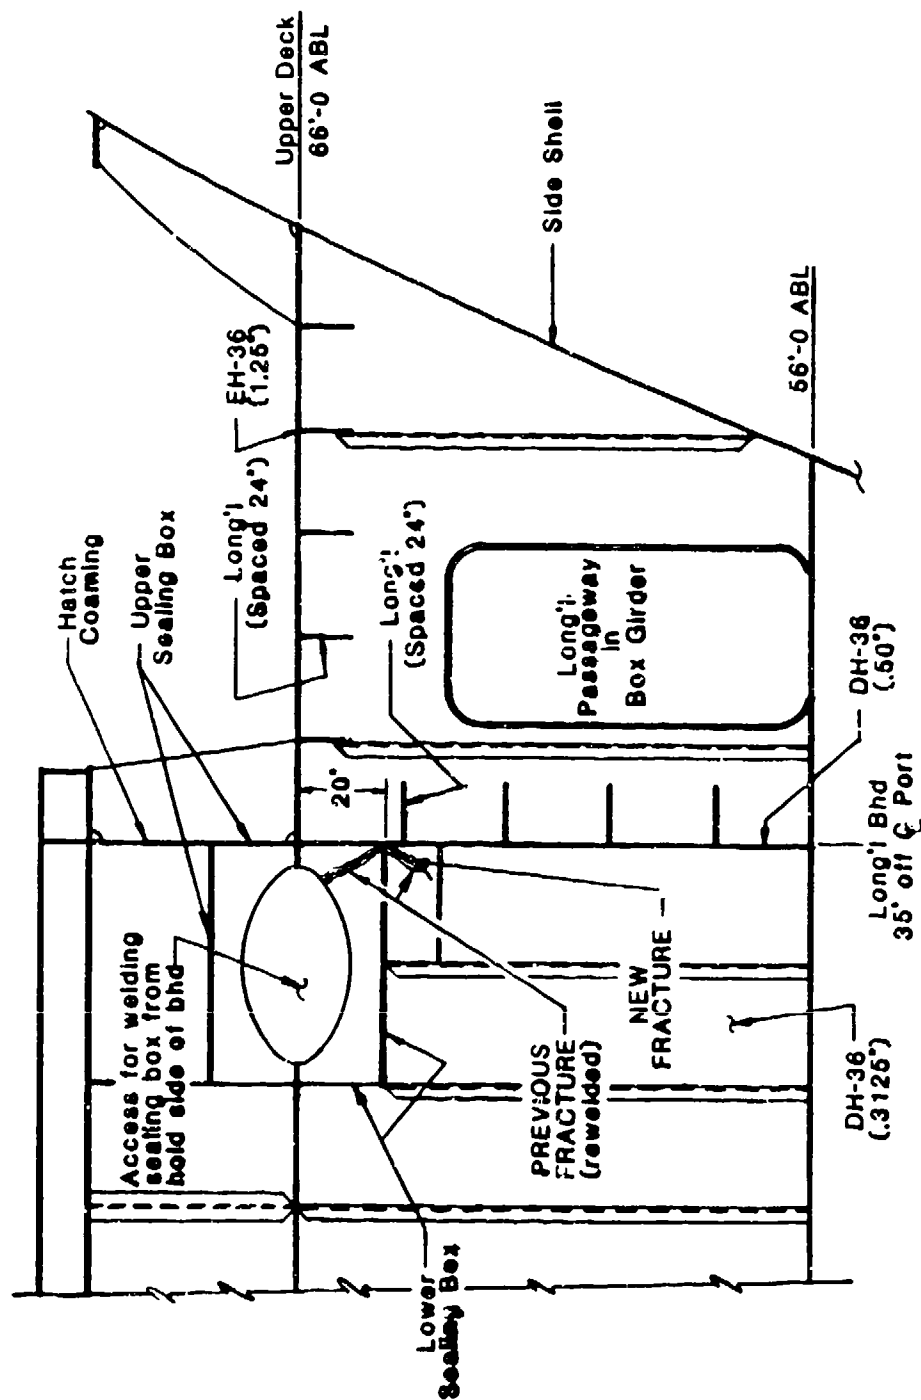
Figure 3-48 Fractured Transverse Bulkhead of a Containership

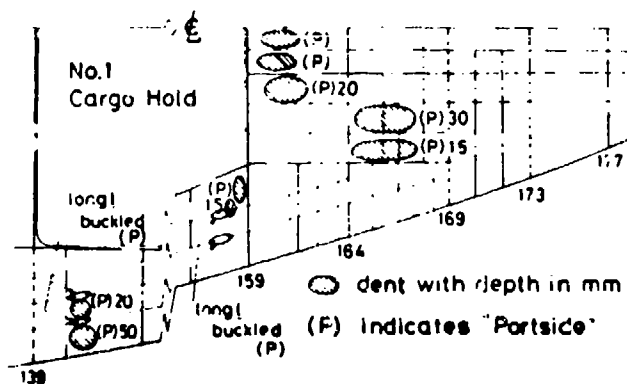
Figure 3-54 Deck Buckling in the Deck of the Containership Bow

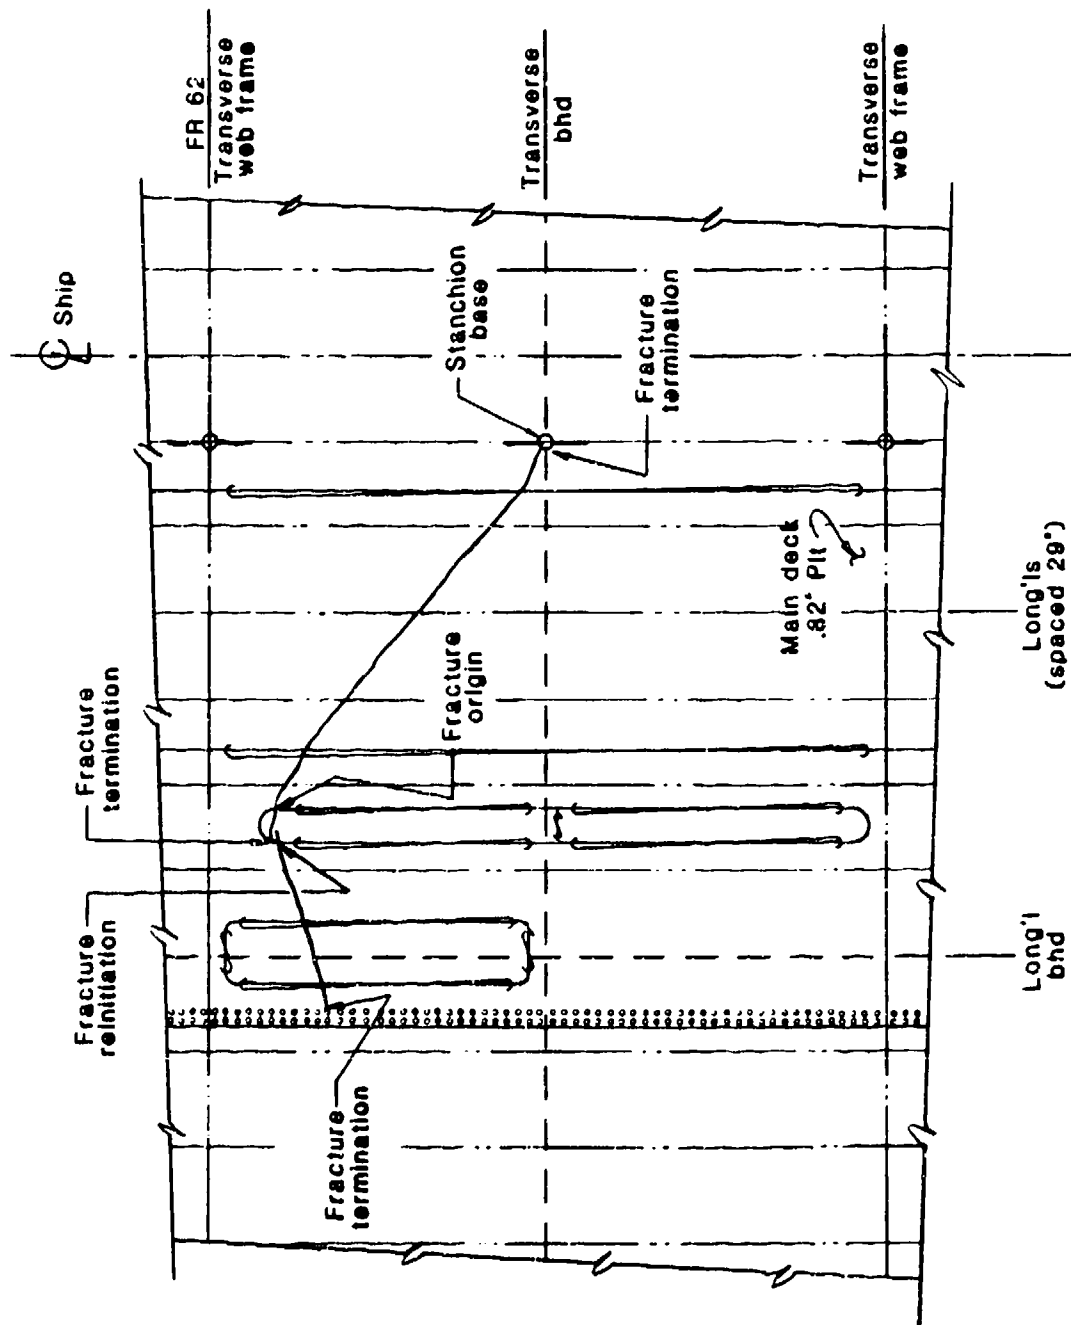
Figure 3-57 Fracture in the Deck of the Jumboized T-2 Tanker

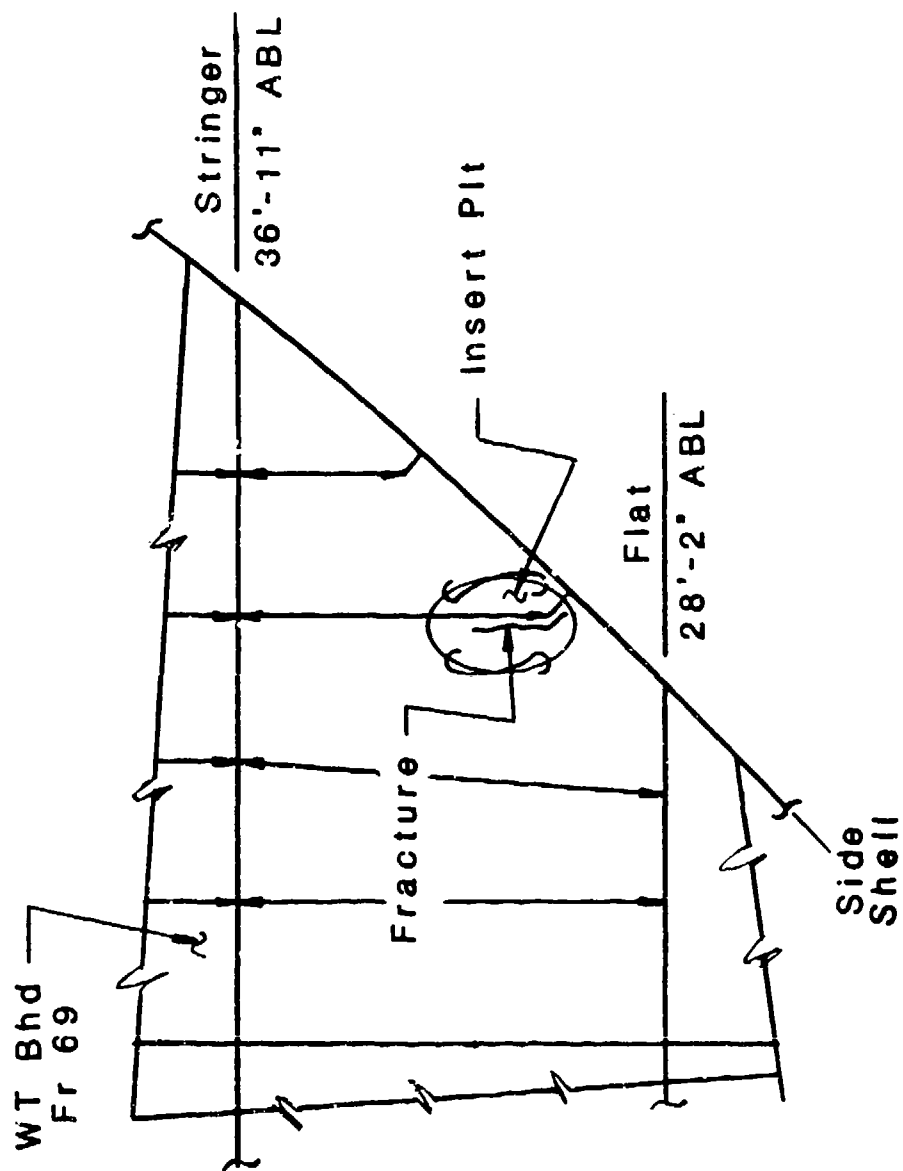
Figure 3-59 Fracture on the Transverse Bulkhead of a Tanker

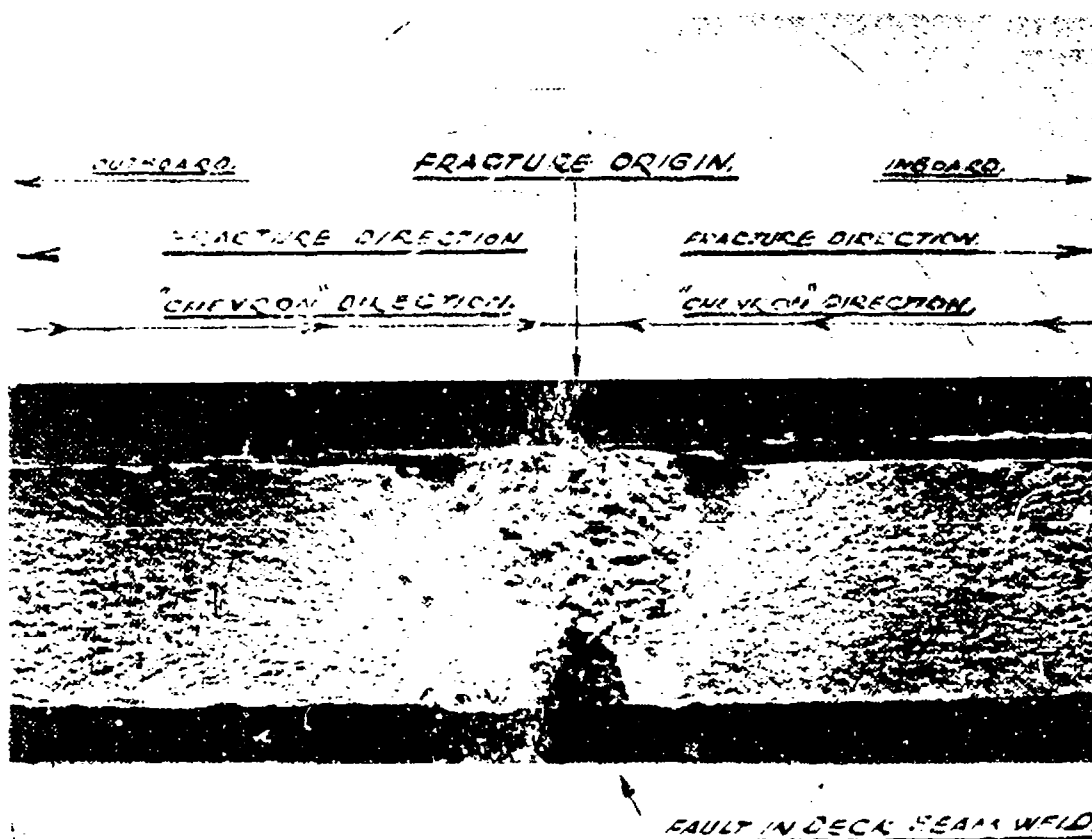
Figure 3-63 Fracture Origin of the Fracture on the Great Lakes Bulk Carrier

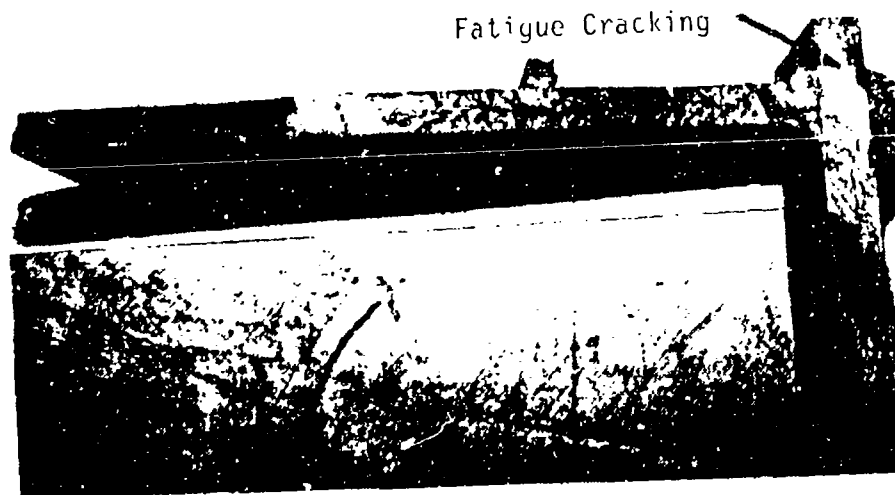
The project investigators believe that the fracture initiated by fatigue along the toe of a butt weld in the bulkhead, probably at several places, and progressed along the seam by both fatigue and brittle fracture. A clear brittle fracture region occurs in the bulkhead below the longitudinal shelf plate. The

Figure 3-66 Detail of Chevron Marks and Fatigue Initiation
